**Flood Control Project Maintenance
Levee Inspections**
LMA District Cover Sheet
Spring 2018 Levee Inspection Results

Yolo County Service Area 6

Spring 2018 Levee Inspection Results

| Waterway | | | Bank | Unit Miles |
|---|---|---|---|---|
| Unit No. 01 Right Bank of Sacramento River at Knights Landing | | | Right | 5.87 |

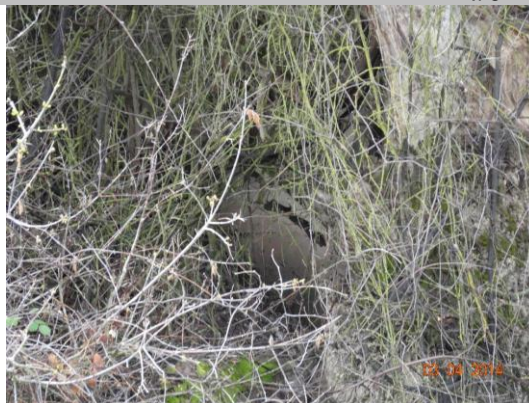
Photo 1 of 3 : UCIP_SP_2018_31904_58228.jpg

Pipe section with holes abandoned on waterward side.

| FS_ID:31904 DS_ID:19516 EP_NO: N/A Repair Type: Non-Urgent Crossing Status: Indicator Found UCIP Comments: Need to properly abandon per Title 23 if corssing is no longer used--debris inside concrete box and near site. Need to contact owner. FIELD_STRUCT_DESC: 48-inch corrugated metal gravity drainage pipe through the levee, 14.5 feet below the crown. Slide gate in a concrete box on the waterside (WS) bank. (Automatic Board Order (ABO) issued as Permit No. Unknown, 1976 - Wallace) [Additional Reference(s): DWR Levee Log, 2005]. FS Date: 3/4/2014 | | | | | |

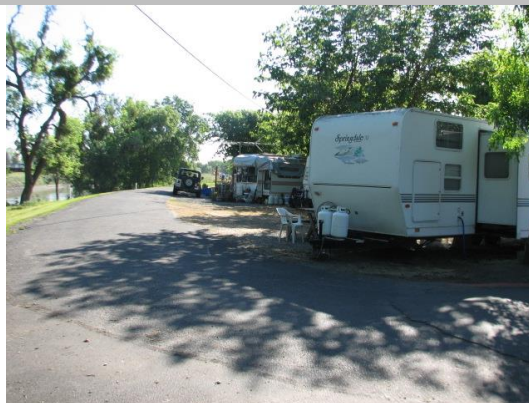
Photo 2 of 2 : SP_2018_NA0022_350_28_20180306_00024.jpg

| RV park runs on and along levee to bridge. | | | | | | |

Trailers on the crown of the levee. Spring 2014

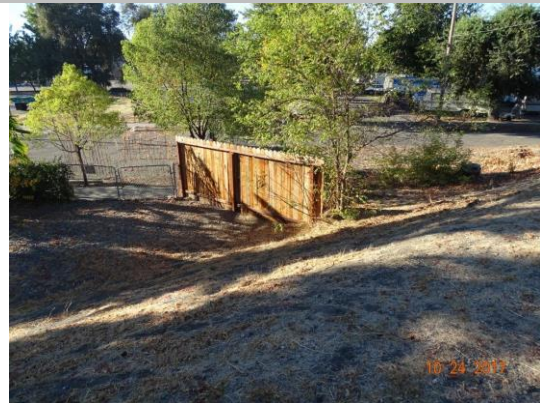
Photo 1 of 1 : SP_2018_NA0022_350_62_20180306_00041.jpg

| CVFPB enforcement item 2016-10754. | | | | | |

View of fence at landside toe. Fall 2017.

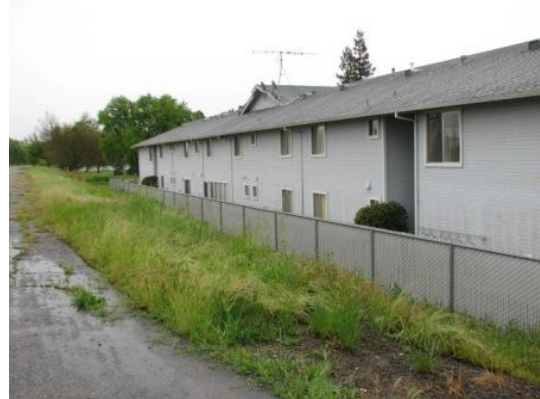
Photo 1 of 1 : SP_2018_NA0022_350_26_20180306_00022.jpg

| Apartments with chainlink fence with lathe woven into it. | | | | | |

The apartments and fence along the toe of the levee. Fall 2013

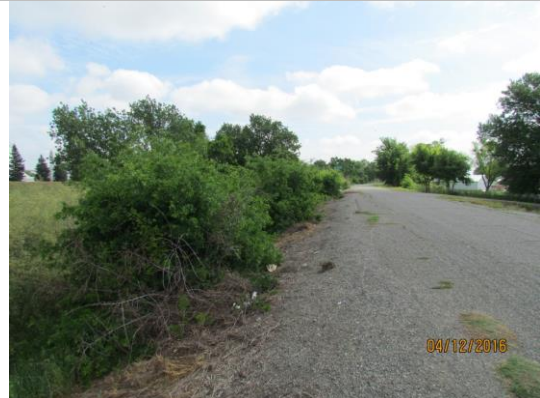
Photo 1 of 1 : SP_2018_NA0022_350_102_20180306_00064.jpg

View of the trees on the waterward side of the levee looking downstream. Spring 2016.

| Remove trees less than 4" in diameter at chest height. | | | | | |

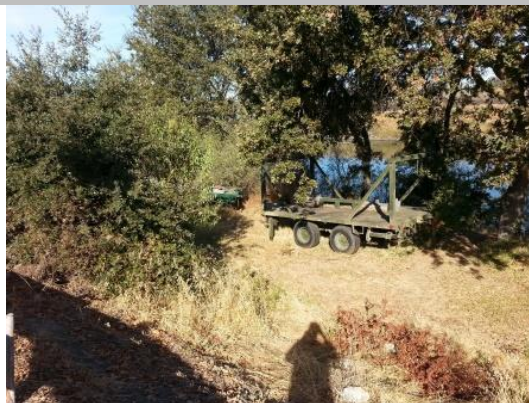
Photo 1 of 1 : SP_2018_NA0022_350_71_20180306_00043.jpg

| USACE trailers on waterside berm. | | | | | |

Vehicles and equipment on waterward side of the levee. Fall inspection 10/07/2016.

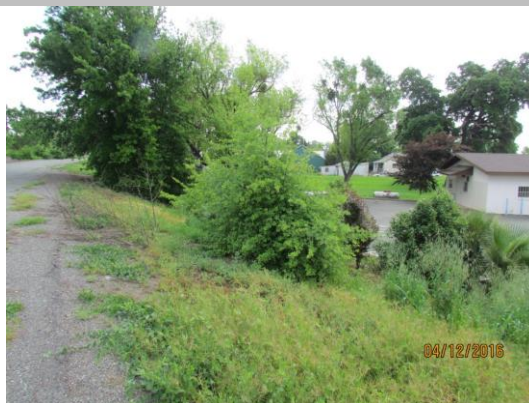
Photo 1 of 1 : SP_2018_NA0022_350_104_20180306_00065.jpg

View of the tree on the landward side of the levee looking downstream. Spring 2016.

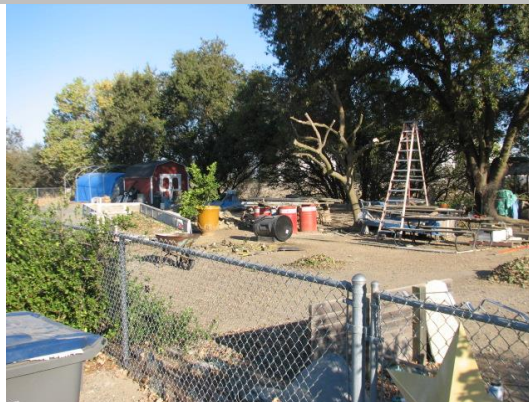
Photo 1 of 1 : SP_2018_NA0022_350_395_20180306_00076.jpg

Material blocking visibility on the waterside of the levee. Fall 2013

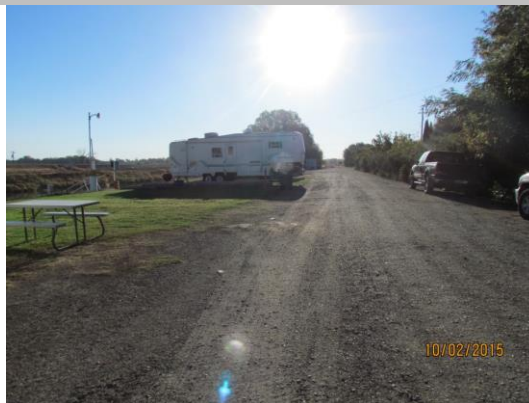
Photo 1 of 1 : SP_2018_NA0022_350_23_20180306_00020.jpg

| Yolo Sutter Yacht Club Permit No. 2778. | | | | | |

View of the Yacht club on the crown of the levee looking downstream.
Fall 2015.

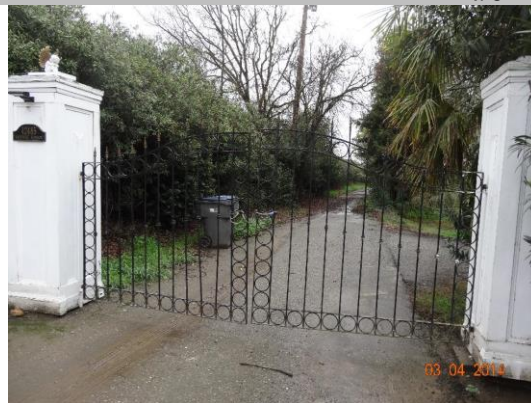
Photo 3 of 3 : UCIP_SP_2018_38188_69561.jpg

Residential property standpipe located behind fence.

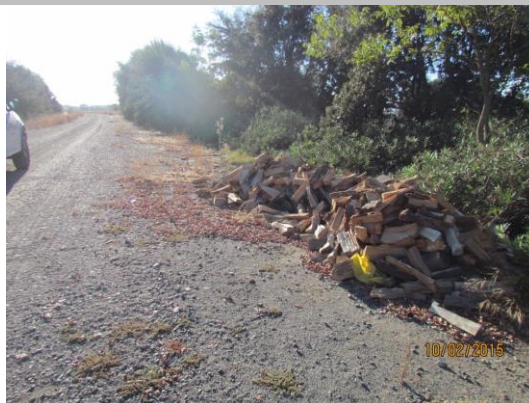
Photo 1 of 1 : SP_2018_NA0022_350_70_20180306_00042.jpg

View of the firewood on the landward side of the levee looking downstream. Fall 2015.

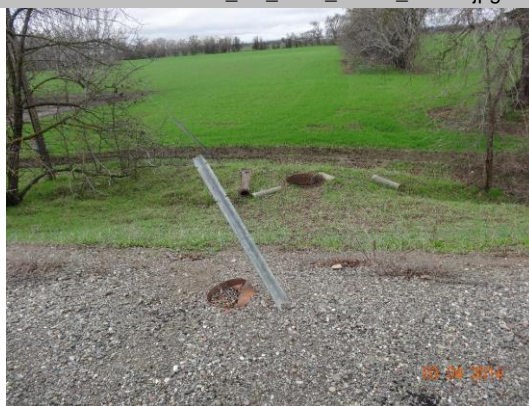
Photo 1 of 3 : UCIP_SP_2018_31912_58261.jpg

FS_ID:31912
DS_ID:19522
EP_NO: 6296
Repair Type: Non-Urgent
Crossing Status: Found
UCIP Comments: Siphon breaker housing on landward slope unit damaged and debris scattered on landward side. Unable to determine if crossing is still in use. Need to contact owner to determine status of crossing.
FIELD_STRUCT_DESC: 12-inch (not 14-inch as indicated in the desk study) coated steel irrigation discharge pipe through the levee, 11.8 feet below the crown. Standard corrugated metal cutoff wall around pipe at centerline of levee. 1.25-inch electrical conduit through the levee. Electrical control panel on the waterside (WS) slope. Slant pump mounted on a steel structure on the riverbank. Siphon breaker on the landside (LS) shoulder. Pipe extends from pump to existing irrigation ditch at the LS toe. (Plans to install a pump and pipe through the levee authorized under Permit No. 6296, 1968 - Emma Collier). [Additional Reference(s): DWR Levee Log, 2005].

View of landward side.

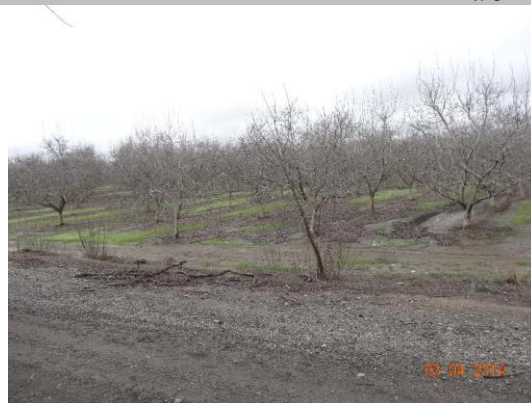
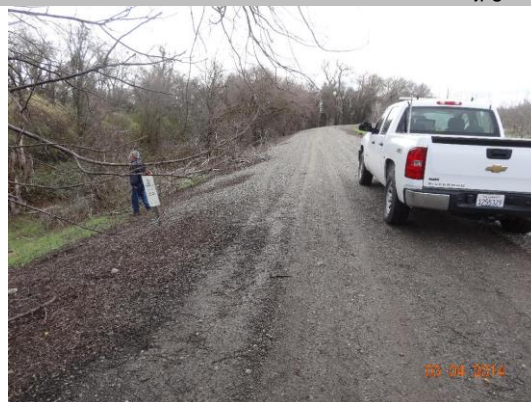
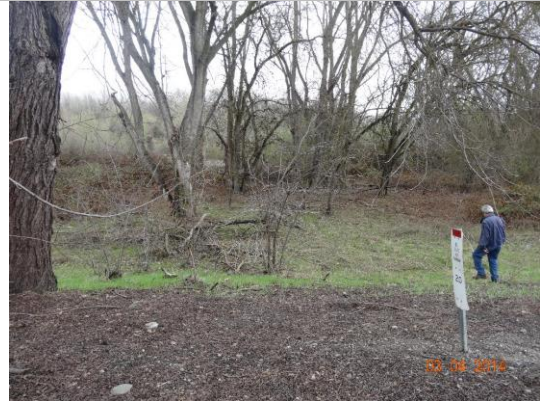
View of landward side.

View of levee crown at crossing.

| FS_ID:40536 DS_ID:19524 EP_NO: 9413 Repair Type: Non-Urgent Crossing Status: Found UCIP Comments: Alignment through levee unknown--no signs of crossing through landward side. Need to contact owner to determine status of crossing. This crossing appears to have been updated since 1970s. FIELD_STRUCT_DESC: 24-inch pipe of an unknown material or purpose through the levee, 15.5 feet below the crown. Gate valve on the landside (LS) end. Ramp on the waterside (WS) slope. (Retention of a 30-inch pipe through the levee and a slide gate in a corrugated metal pipe [CMP] riser on both slopes authorized under Automatic Board Order (ABO) issued as Permit No. 9413, 1974 - Wallace Construction Company). Added appurtenances noticed in 2014: pump, metal frame platform, flow meter, and control panel on the WS. Appurtenances could be associated with Permit No. 12804. This appears to be the same entry as DS_ID 19538. [Additional Reference(s): DWR Levee Log, 2005]. FS Date: 3/4/2014 | | | | | | |

View of waterward side.

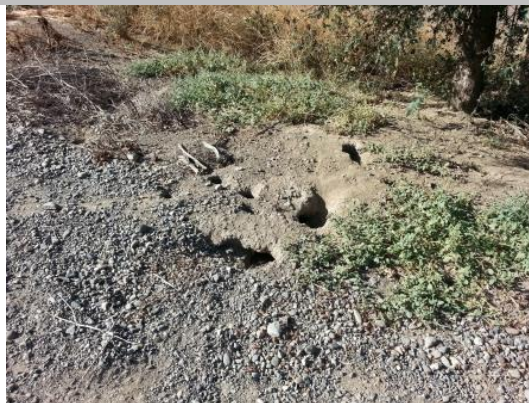
Photo 2 of 2 : SP_2018_NA0022_350_117_20180306_00068.jpg

Series of animal burrows on LS slope of the levee. Fall inspection 10/07/2016.

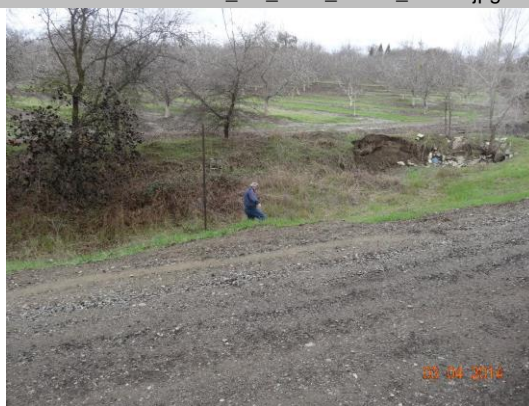
Photo 3 of 3 : UCIP_SP_2018_31915_58272.jpg

| FS_ID:31915 DS_ID:19538 EP_NO: N/A Repair Type: Non-Urgent Crossing Status: Indicator Found UCIP Comments: Buried gate valve on landward slope. Crossing appears to be non-functional. Landward pipe section across canal has deteriorated. Will need to contact owner to determine status of crossing. If crossing is not in use owner will need to contact the CVFPB to abandon properly according to Title 23. FIELD_STRUCT_DESC: 20-inch corrugated metal gravity drainage pipe through the levee, at an unknown depth. 20-inch gate valve on the landside (LS) slope. This crossing could be the same record as DS_ID 19524 - unable to confirm. [Additional Reference(s): USACE Sacramento O&M Manual 127, June 1953, (Station 208+15)]. FS Date: 3/4/2014 | | | | | | |

View of landward side.

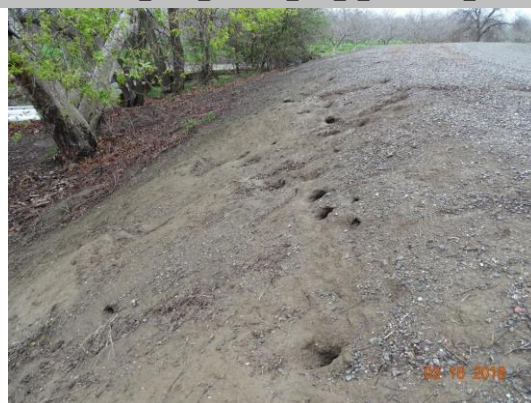
Photo 1 of 2 : SP_2018_NA0022_350_8_20180315_00143.jpg

| More than 5 holes on 25-foot stretch. | | | | | |

View of rodent holes on the landside slope. Spring 2018.

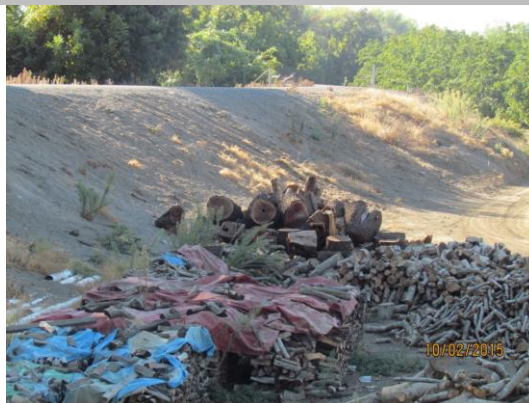
Photo 1 of 1 : SP_2018_NA0022_350_39_20180306_00030.jpg

| Firewood is placed at the levee toe. | | | | | |

View of the growing firewood at the toe of the landward side of the levee looking downstream. Fall 2015.

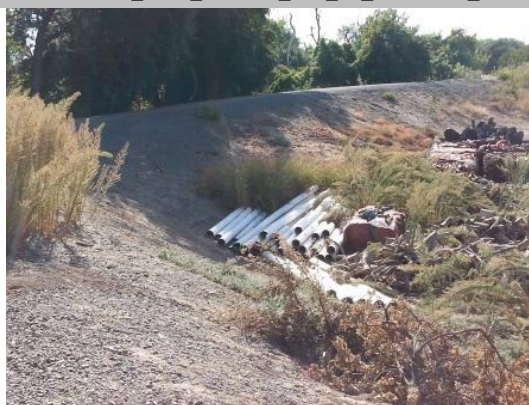
Photo 1 of 2 : SP_2018_NA0022_350_40_20180306_00031.jpg

| Equipment is placed at the toe of the levee. | | | | | |

An updated view of the equipment on landward side. Fall inspection 10/07/2016.

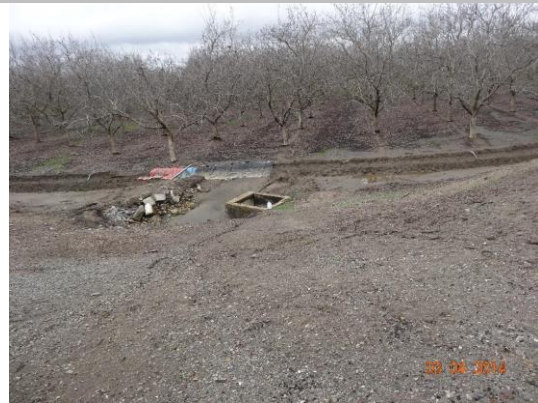
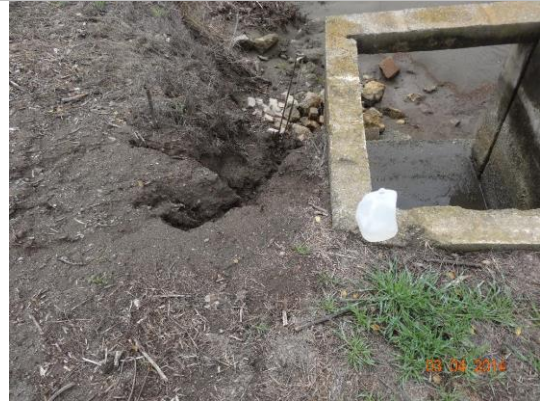
| FS_ID:49982 DS_ID:19525 EP_NO: N/A Repair Type: Urgent Crossing Status: Indicator Found UCIP Comments: 7/13/2016 same as last inspection. Erosion has progressed--Need to coordinate with owner to address erosion on LS toe. (DWR UCIP - omagana)3/04/2014 Surface erosion near concrete box on landward side. Unable to determine if crossing is leaking or if pump is pulling sand from waterward side. Need to contact owner to determine status of crossing and to check integrity of crossing. (DWR UCIP - omagana) FIELD_STRUCT_DESC: 16-inch steel irrigation discharge pipe through the levee, 4 feet below the crown (1955 levee log indicates crossing is 18.9 feet below the crown). Concrete well and pump house on the waterside (WS). Screw gate in pump house. Slant pump mounted on a steel structure on the riverbank. 4-foot by 4-foot concrete discharge box on the landside (LS) toe. Overhead power line and anchor crosses levee. Pole on each shoulder. (Plans for installation of a pump on the bank and to utilize an existing discharge pipe through the levee authorized under Permit No. 5951, 1967 - Elizabeth Huston). [Additional Reference(s): DWR Levee Log, 2005. USACE Sacramento O&M Manual 127, June 1953, (Station 192+60)]. FS Date: 7/13/2016 | | | | | |

View of LS toe.

Slope erosion near concrete box.

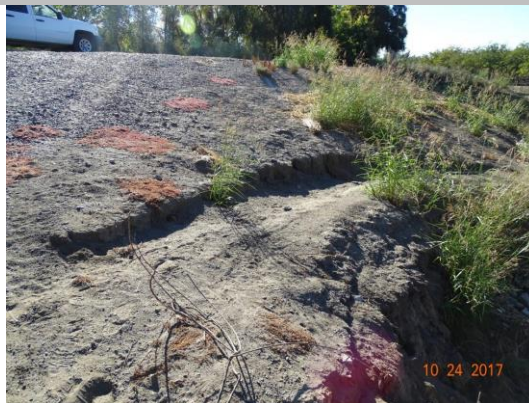
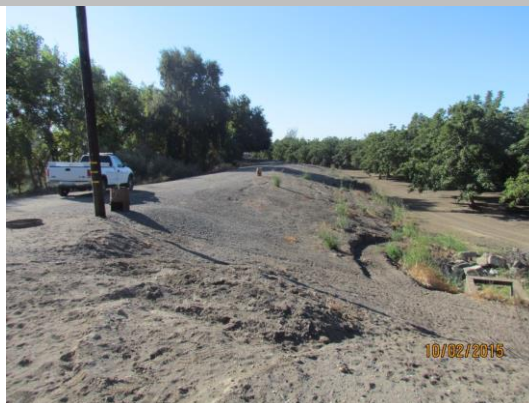
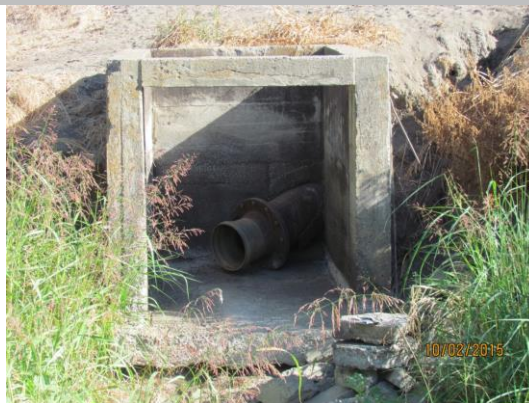
Updated view of erosion on landside slope. Fall 2017.

Perspective view of the erosion around the pipe on the landward side of the levee looking downstream. Fall 2015.

| There seems to be an erosion around the concrete box encasing the pipe. | | | | | | |

View of the pipe in the concrete box. Fall 2015.

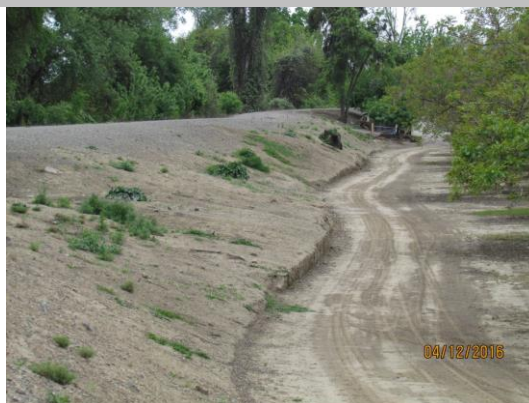
Photo 2 of 2 : SP_2018_NA0022_350_94_20180306_00059.jpg

View of the cut at the levee toe on the landward side looking downstream. Spring 2016.

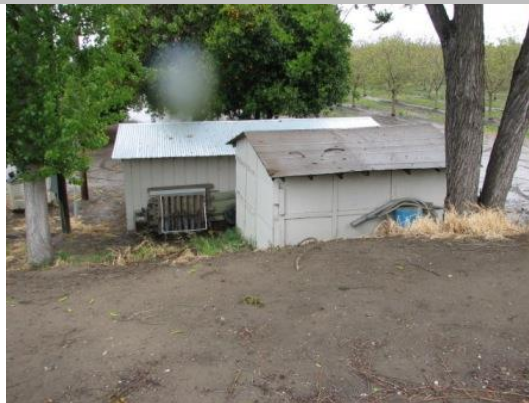
Photo 1 of 1 : SP_2018_NA0022_350_11_20180306_00013.jpg

Garage at toe.

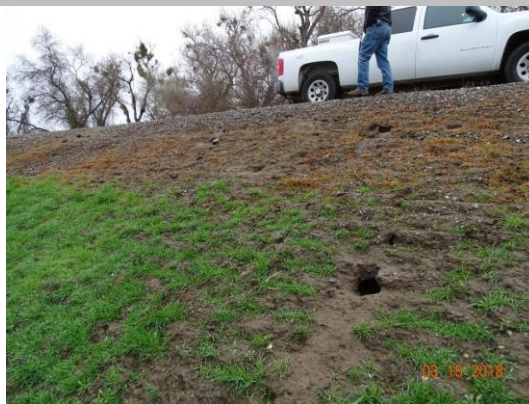
Photo 1 of 1 : SP_2018_NA0022_350_52_20180315_00144.jpg

View of rodent holes on the landside slope. Spring 2018.

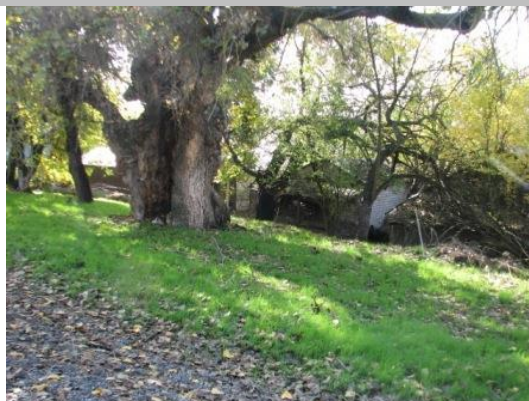
Photo 1 of 2 : SP_2018_NA0022_350_12_20180306_00014.jpg

Buildings are located at the toe of the levee. Fall 2012

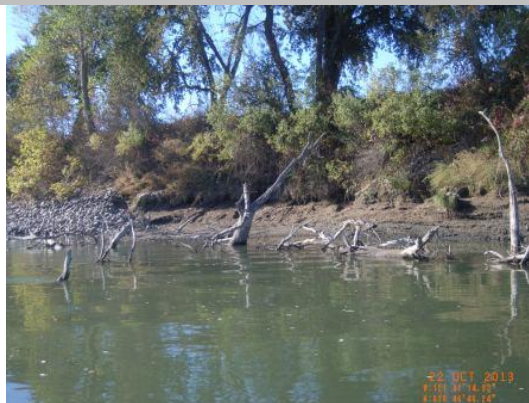
Photo 1 of 1 : SP_2018_NA0022_350_5_20180306_00006.jpg

| 2006 - Short section is into the levee toe, rest is near the levee toe. Mass failure and fluvial erosion of depositional material. Rock at the upstream and downstream ends. 2011 - Minor new erosion. 2012 - Slope continues to steepen, tree roots have become exposed, and new eddy formed. 2015: No observed changes. [2015 Site ID: SAC_86-9_R] | | | | | |

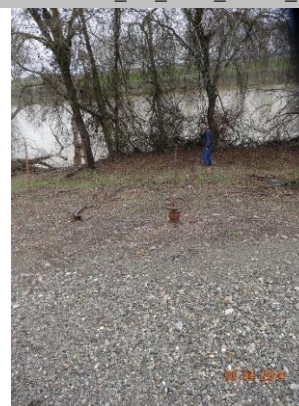
Photo 1 of 3 : UCIP_SP_2018_39858_71841.jpg

| FS_ID:39858 DS_ID:19526 EP_NO: 3205 Repair Type: Non-Urgent Crossing Status: Found UCIP Comments: Need to contact owner to determine status of crossing. If crossing is no longer used need to coordinate with CVFPB for proper abandonment. FIELD_STRUCT_DESC: 12-inch coated steel irrigation discharge pipe through the levee, 4 feet below the crown. Metal cutoff wall. Pump on the waterside (WS). Gate valve on the WS slope. Siphon breaker in an 18-inch concrete riser on the landside (LS) slope. 36-inch concrete standpipe at the LS toe. (Previous pipe referenced as USACE O&M irrigation pipe, Station 144+80, was removed and a 12-inch pipe was reinstalled under Permit No. 3205, 1959 - Mary A. Richardson). [Additional Reference(s): DWR Levee Log, 2005. USACE Sacramento O&M Manual 127, June 1953, (Station 144+80)]. FS Date: 3/4/2014 | | | | | | |

View of waterward side.

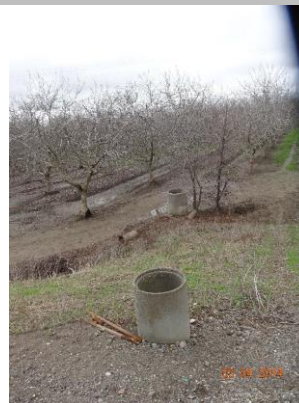
Photo 1 of 3 : UCIP_SP_2018_31916_58275.jpg

| FS_ID:31916 DS_ID:19545 EP_NO: N/A Repair Type: Non-Urgent Crossing Status: Indicator Found UCIP Comments: Need to contact owner--Crossing appears to be abandoned. If crossing is no longer in use, crossing need to be abandoned properly per Title 23. FIELD_STRUCT_DESC: *REMOVED* 12-inch steel irrigation discharge pipe through the levee, at an unknown depth. Pump on the waterside (WS). Concrete standpipe on the landside (LS). (Previous pipe referenced as USACE O&M irrigation pipe, Station 144+80, was removed and a 12-inch pipe was reinstalled under Permit No. 3205, 1959 - Mary A. Richardson). [Additional Reference(s): USACE Sacramento O&M Manual 127, June 1953, (Station 144+80)]. FS Date: 3/4/2014 | | | | | |

View of landward side.

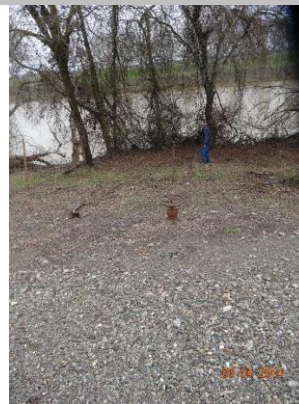
Photo 2 of 3 : UCIP_SP_2018_31916_58274.jpg

View of waterward side.

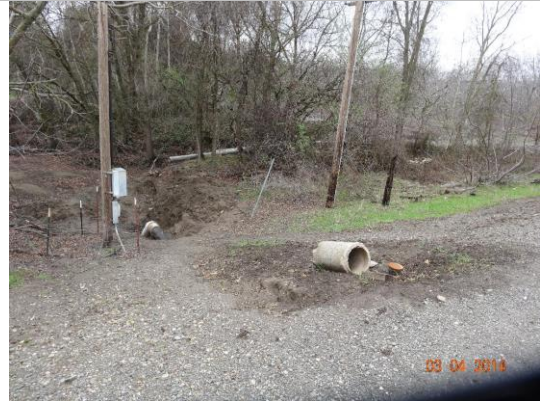
Photo 1 of 3 : UCIP_SP_2018_52542_58279.jpg

| FS_ID:52542 DS_ID:19527 EP_NO: 3729 Repair Type: Urgent Crossing Status: Found UCIP Comments: 10/24/2017 Received updated photos of site from DWR levee inspector, Z. Jojola. Photos show levee slope has been disturbed where the flow meter is attached to pipe on the WS and section of the levee has not been backfill per Title 23 requirements. Recommend contacting the owner and coordinating with LMA about the issue. Crossing has been upgraded from Non-Urgent to Urgent due to disturbance of levee section. (DWR UCIP - O. Magana)03/04/2014 Crossing has been modified. Need to contact owner to determine additional information pertaining to the modifications. (DWR UCIP - O. Magana) FIELD_STRUCT_DESC: 10-inch irrigation discharge pipe of an unknown material through the levee, 3 feet below the crown. Metal cutoff wall. 1.5-inch electrical conduit through the levee, 1 foot below the crown. Service pole and meter at the landside (LS) toe. Pump and gate valve on the riverbank with an access ramp. Siphon breaker in a 12-inch concrete riser on the LS shoulder. (Plans for installation of a 10-inch centrifugal pump on the bank with a discharge pipe through the levee authorized under Permit No. 3729, 1961 - Clayton Russell). [Additional Reference(s): DWR Levee Log, 2005]. FS Date: 3/4/2014 | | | | | | |

View of landward side, photo 1 of 2.

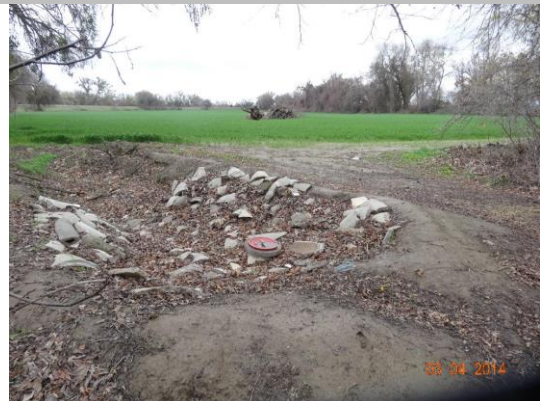
Photo 2 of 3 : UCIP_SP_2018_52542_58282.jpg

View of landward side, photo 2 of 2.

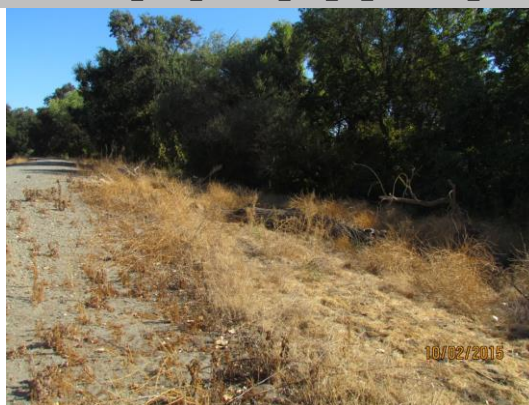
Photo 1 of 1 : SP_2018_NA0022_350_89_20180306_00057.jpg

View of the fallen tree on the waterward side of the levee looking upstream. Fall 2015.

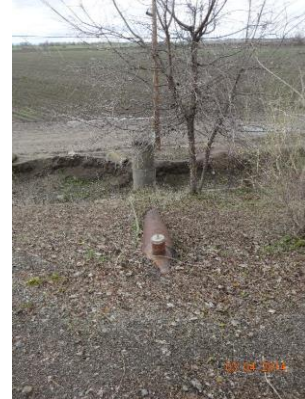
Photo 1 of 3 : UCIP_SP_2018_38999_57948.jpg

| UCIP Comments: Need to contact owner to determine status of crossing. CMP riser damage on waterward slope. | | | | | |

View of landward side.

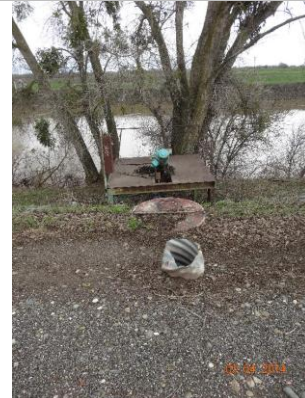
Photo 2 of 3 : UCIP_SP_2018_38999_57947.jpg

View of waterward side.

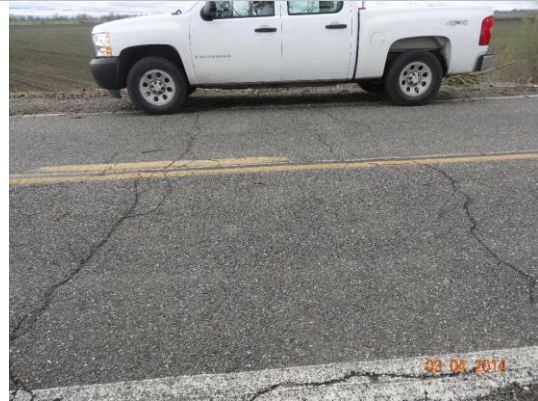
Photo 3 of 3 : UCIP_SP_2018_38999_57946.jpg

View of levee crown at crossing.

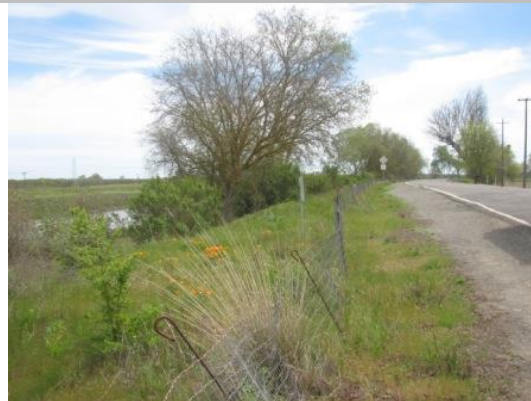
Photo 1 of 2 : SP_2018_NA0022_350_36_20180306_00027.jpg

Another view of the site.

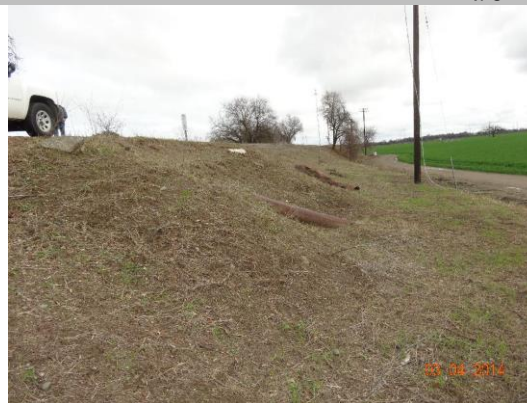
Photo 1 of 3 : UCIP_SP_2018_31986_58442.jpg

| FS_ID:31986 DS_ID:19530 EP_NO: 9409 Repair Type: Non-Urgent Crossing Status: Found UCIP Comments: Pump station not found. Crossing appears to be abandon. Need to contact owner to determine status. Repair site on waterward side--waterward slope revegetated. FIELD_STRUCT_DESC: 16-inch steel irrigation discharge pipe through the levee, 6.4 feet below the crown. Pump and control valve on the riverbank. Ramp on the landside (LS) slope. (Retention of a 16-inch pipe through the levee and a pump on the riverbank authorized under Automatic Board Order (ABO) issued as Permit No. 9409, 1974 - Clayton Russell). [Additional Reference(s): DWR Levee Log, 2005]. FS Date: 3/4/2014 | | | | | | |

View of landward side.

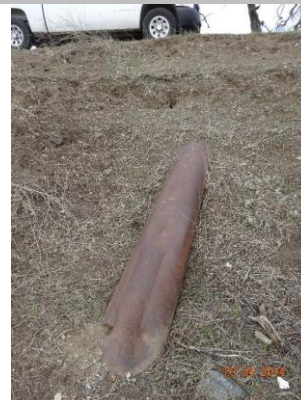
Photo 2 of 3 : UCIP_SP_2018_31986_58439.jpg

Pipe through levee punctured visible on landward slope.

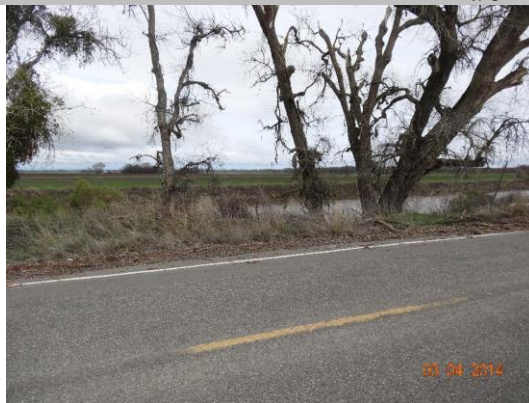
Photo 3 of 3 : UCIP_SP_2018_31986_58441.jpg

View of waterward side.

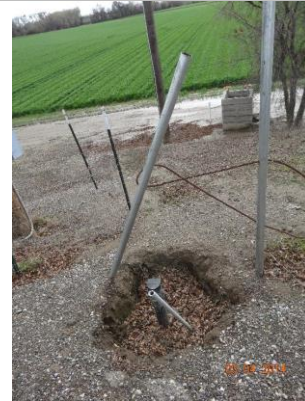
Photo 1 of 3 : UCIP_SP_2018_49983_69573.jpg

| FS_ID:49983 DS_ID:19537 EP_NO: 18298 Repair Type: Urgent Crossing Status: Found UCIP Comments: 7/13/2016 same as last inspection - hole is still present near siphon breaker. Dense vegetation present and limits the inspector's visibility to identify signs of pipe failure (leaks) along the WS and LS slopes. Recommend removing vegetation along pipe alignment to conduct proper inspection of structure and appurtenances. (DWR UCIP - omagana)3/04/2014 Subsidence visible where siphon breaker is located on landward side. Unable to determine if subsidence is due to poor compaction or leak at siphon breaker. Need to contact owner to address issue. (DWR UCIP - omagana) FIELD_STRUCT_DESC: 14-inch coated steel water pipe through the levee, 2 feet below the crown. Pump platform is supported by 6 pilings on the waterside (WS) slope. Siphon breaker and air release valve on the landside (LS) shoulder. Concrete distribution box on the LS toe. Rock riprap along the WS slope. (Permit No. 18298, 2007 - Heidrick, [permit not in database]). FS Date: 7/13/2016 | | | | | |

View of LS--subsidence near levee crown.

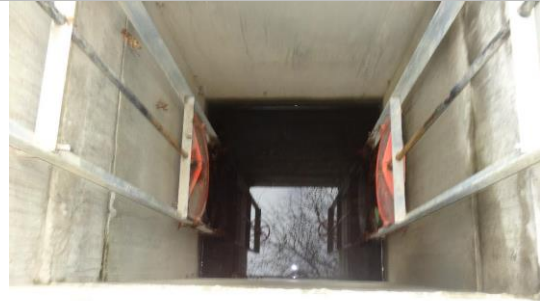
Photo 3 of 3 : UCIP_SP_2018_49983_69575.jpg

Inside view of concrete box located on LS toe.

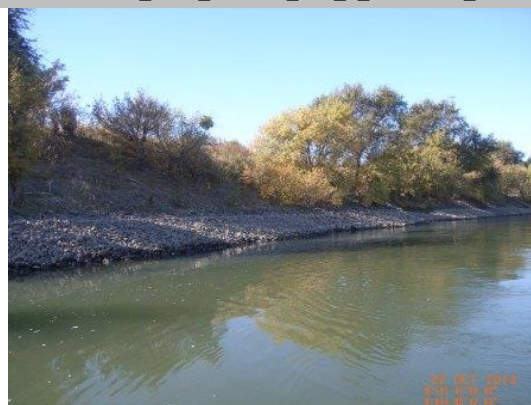
Photo 1 of 1 : SP_2018_NA0022_350_3_20180306_00002.jpg

| 2009 - Erosion into the levee toe. Some cobbles have been dumped into the erosion pockets. 2010 - Old cobble site starting to unravel. 2012 - Slope continues to steepen and new animal holes. 2013 - Downstream cobble is unraveling. 2015: No observed changes. [2015 Site ID: SAC_85-4_R] | | | | | |

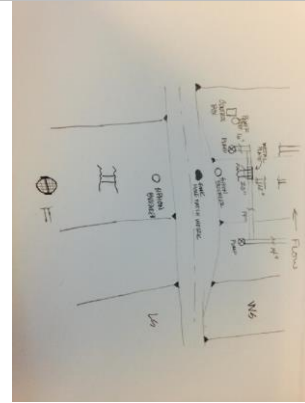
Photo 1 of 3 : UCIP_SP_2018_52543_58451.jpg

UCIP Comments: 10/24/2017 Received updated photos from DWR levee inspector, Z. Jojola, and the photos show some depression along LS slope. Road patch repair is still visible on levee road, recommend an internal integrity inspection of pipe to determine the condition through the levee and slopes. (DWR UCIP - O. Magana) 07/13/2016 Same as last inspection. Sink hole repair visible on levee road. Recommend contacting owner to determine if an internal integrity inspection of the pipe was completed to confirm sink hole was not the cause of the damage to road. If no internal integrity inspection was completed during road repair, recommend an internal integrity inspection be completed at this location based on the sink hole that developed along pipe alignment and based on age of pipe. (DWR UCIP - omagana)03/04/2014 Signs of sink hole repair on levee crown. Owner will need to contact CVFPB to address sink hole repair. (DWR UCIP - omagana)

Plan view of crossing and appurtenances at CLM 4.692.

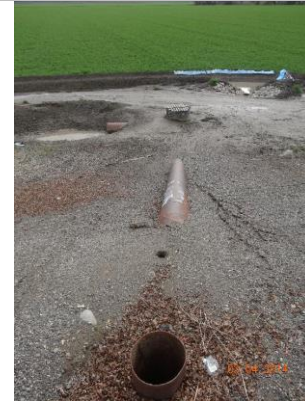
Photo 2 of 3 : UCIP_SP_2018_52543_58457.jpg

View of LS.

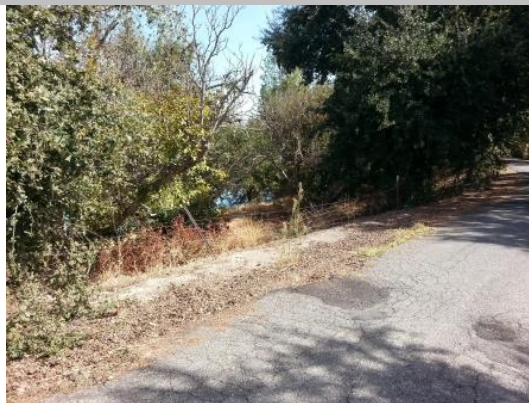
Photo 1 of 1 : SP_2018_NA0022_350_145_20180306_00075.jpg

Fence on WS slope near levee crown. Fall inspection 10/07/2016.

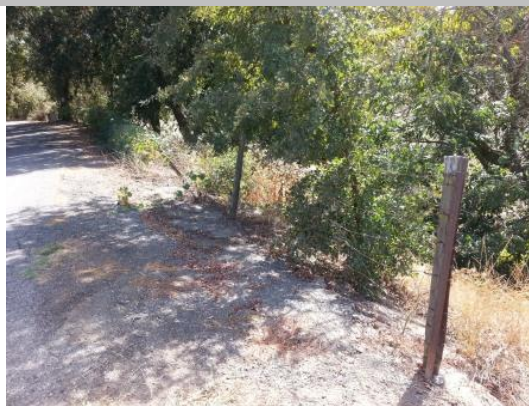
Photo 1 of 1 : SP_2018_NA0022_350_144_20180306_00074.jpg

Fence on LS slope near levee crown. Fall inspection 10/07/2016.

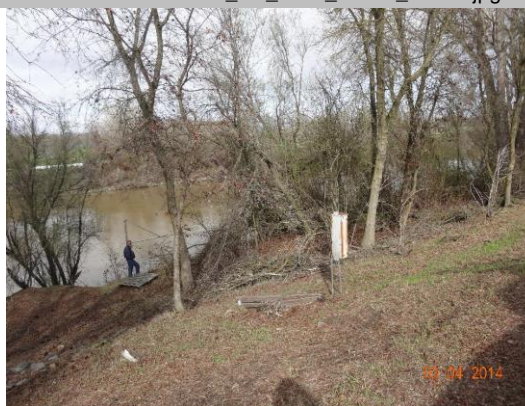
Photo 1 of 3 : UCIP_SP_2018_31927_58332.jpg

View of waterward side.

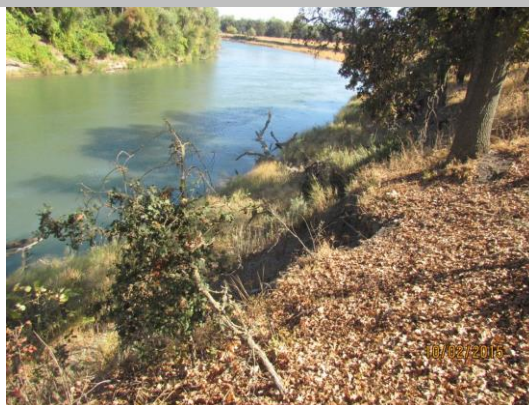
Photo 3 of 3 : SP_2018_NA0022_350_84_20180306_00054.jpg

View of the erosion on the waterward side of the levee looking downstream. Fall 2015.

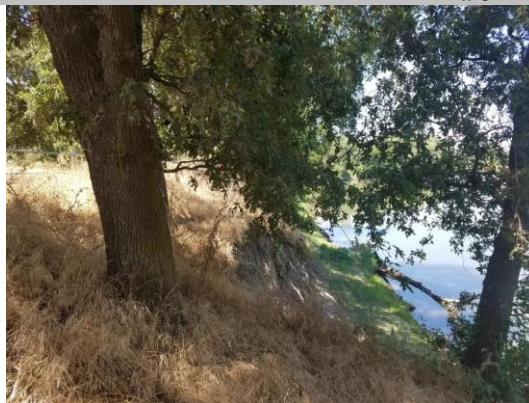
Photo 1 of 1 : LEVAL_SP_2018_490_4925.jpg

| Notes: wide crown. Erosion not in prism. May be a new erosion pocket, but need to compare to fsrp data. Old veg still present. | | | | | |
